# **HISTORIC PRESERVATION PLAN**

## **CARY BARN (AKA SCOTT FARM BARN)**

88 Mountainside Road  
Mendham Borough, Morris County, New Jersey

23 February 2021

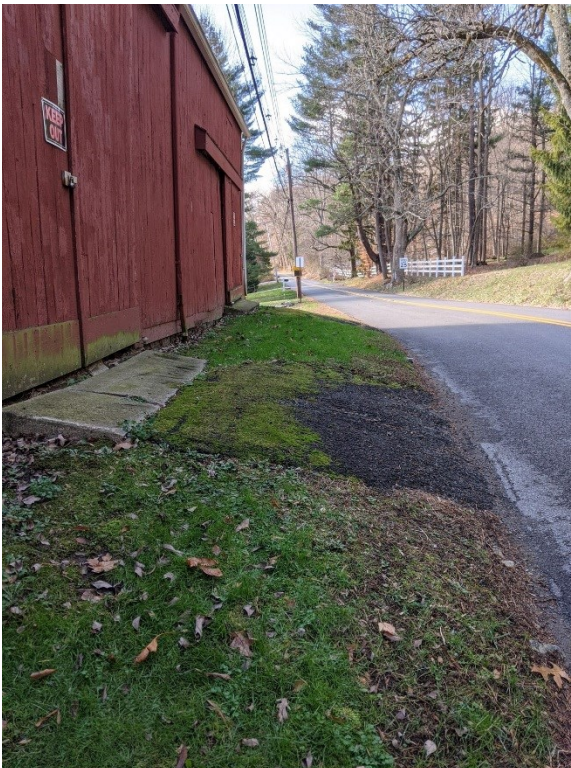
**Photo S-2.** View of the existing asphalt and concrete ramp leading to the main entrance door. Note the close proximity of the building to the road.

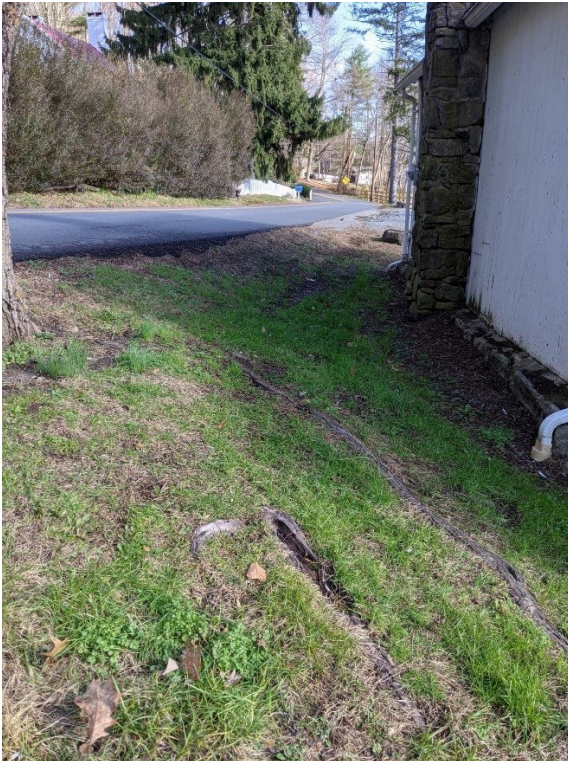
**Photo S-4.** View of the steep grade change from the road along the northern edge of the property

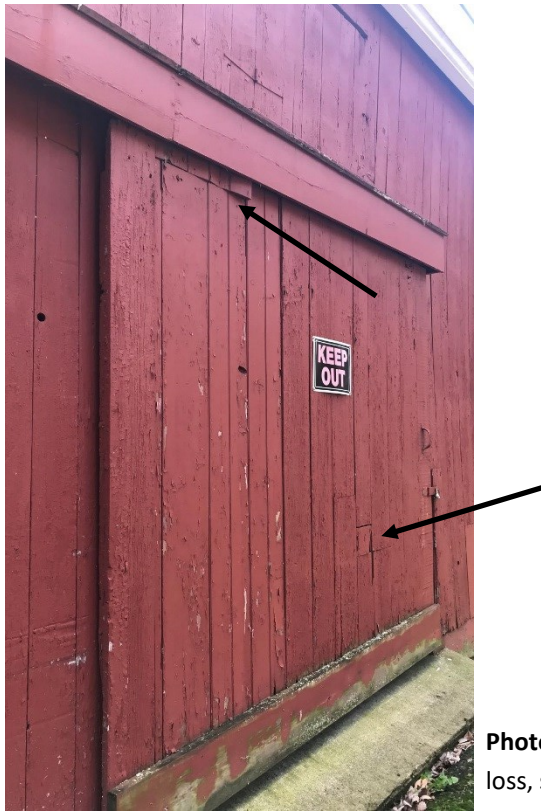
**Photo E-5.** View of door D101 at the north elevation. Note the paint loss, splits in boards, and few replacement boards.

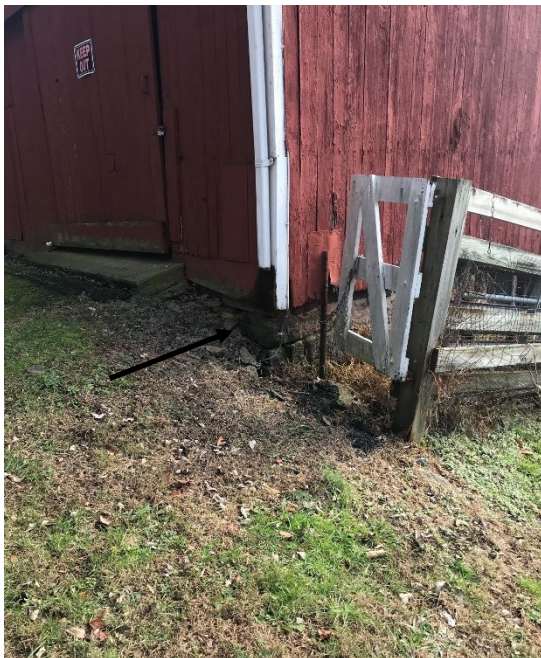
**Photo E-6.** View of the cut-off leader at the northwest corner and the related wood rot and biological growth.

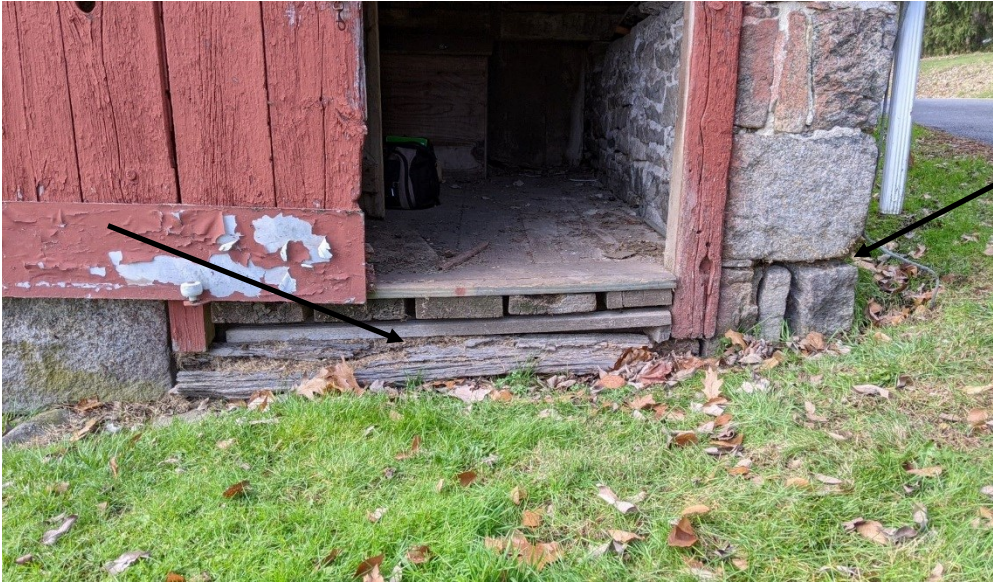
**Photo E-7.** View of the mismatched infill below door D102. Also note the mortar loss at the corner of the foundation and the paint loss at the door.

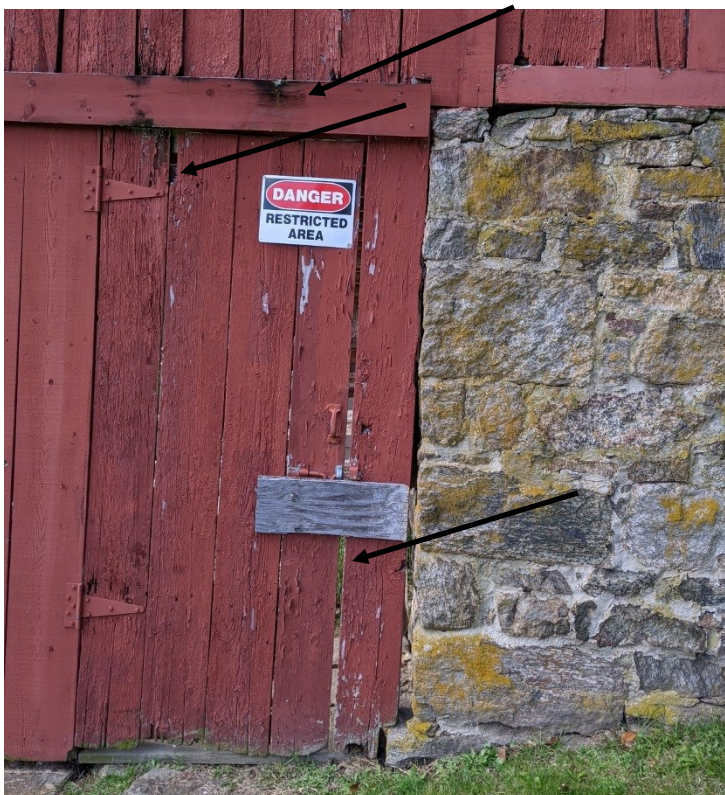
**Photo E-8.** View of door D102 at the east elevation showing wood loss, paint loss, and separation between boards. Also note the wood rot at the door hood above, and the loss at the ends of the siding boards.

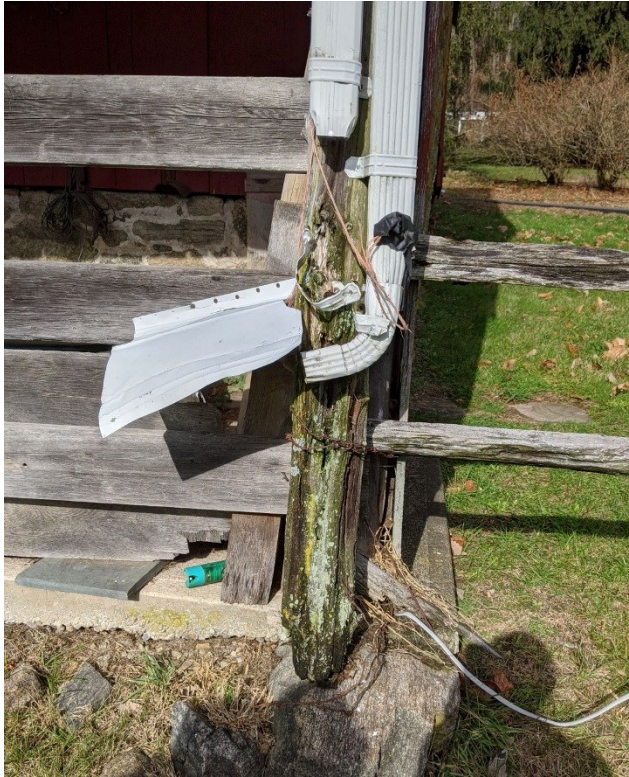
**Photo E-9.** View of the wood post at the southeast corner, which exhibits significant loss and biological growth due to the position of the adjacent leader.

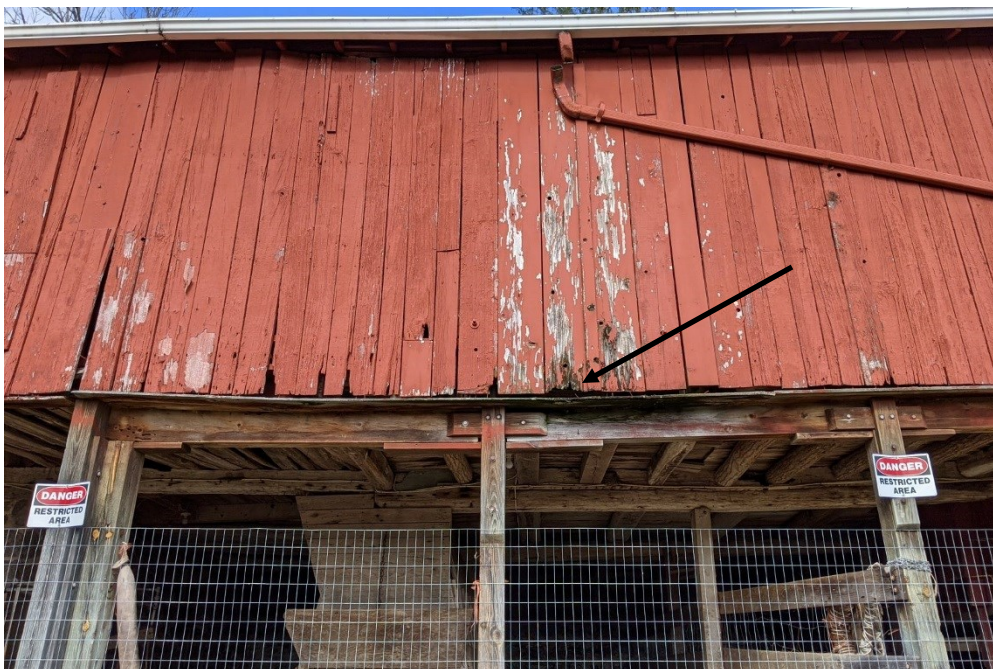
**Photo E-10.** View of the south elevation showing significant paint loss and wood rot at the siding caused by the disconnected leader above. Also note the projecting floor board, which has pulled away from the ends of the siding.

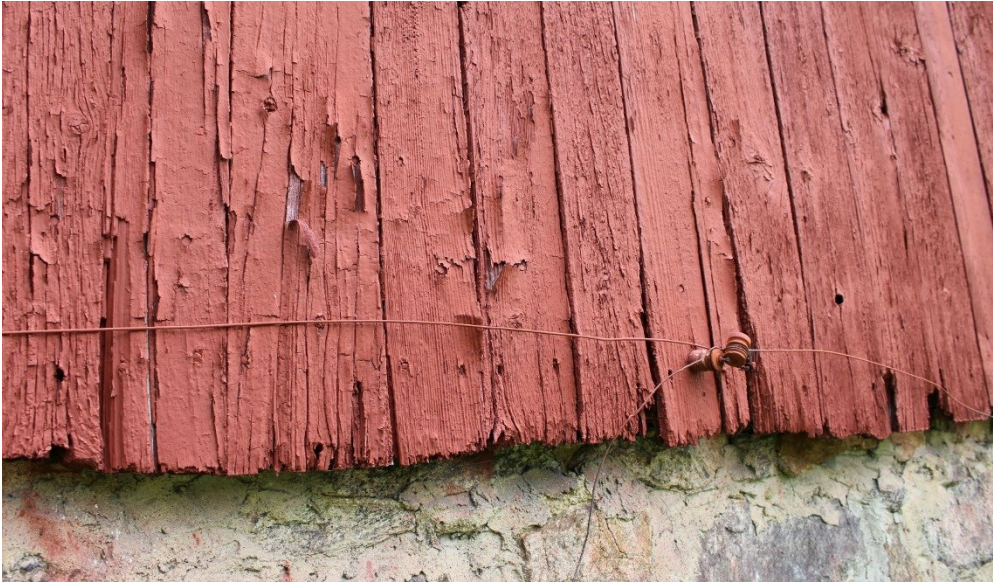
**Photo E-11.** Detail view of the bottom edges of siding boards at the west elevation showing wood loss, splits, and paint loss.

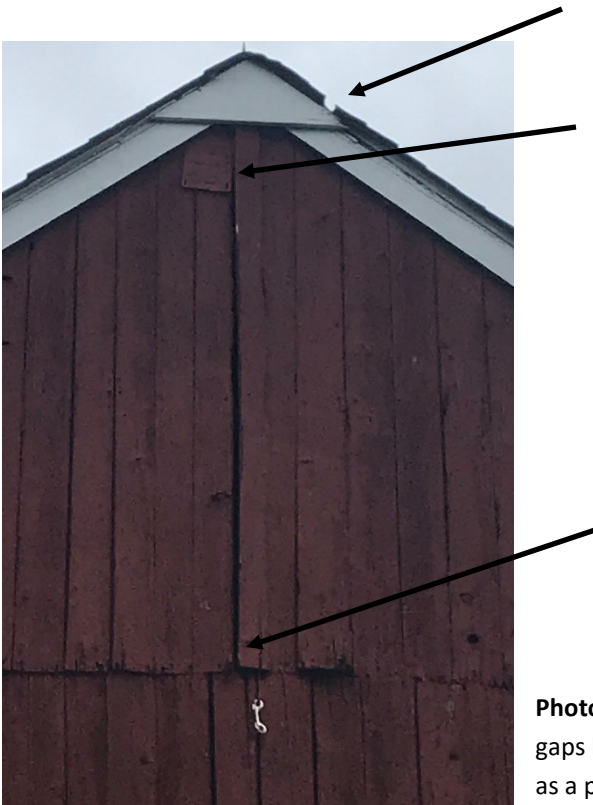
**Photo E-12.** View of the peak of the west gable end showing gaps between boards, lifting of boards, and a license plate used as a patch. Also note the gap at the asphalt roofing.

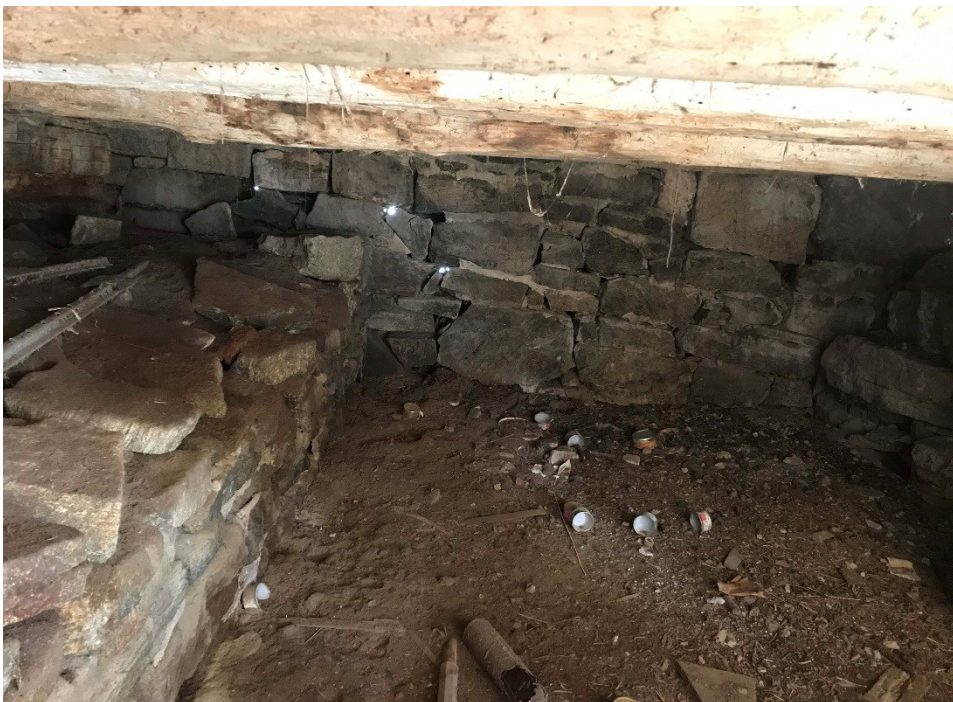
**Photo I-10.** View of the crawlspace showing mortar loss at the east foundation wall. Also note the debris on the dirt floor.

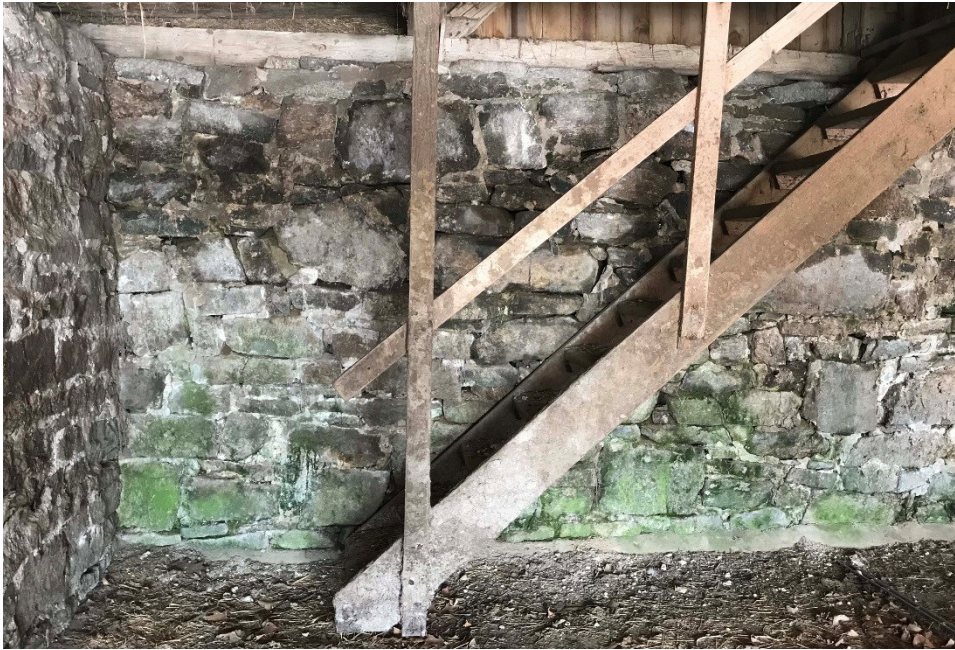
**Photo I-11.** View showing mortar loss and biological growth at the north foundation wall in Room 001.

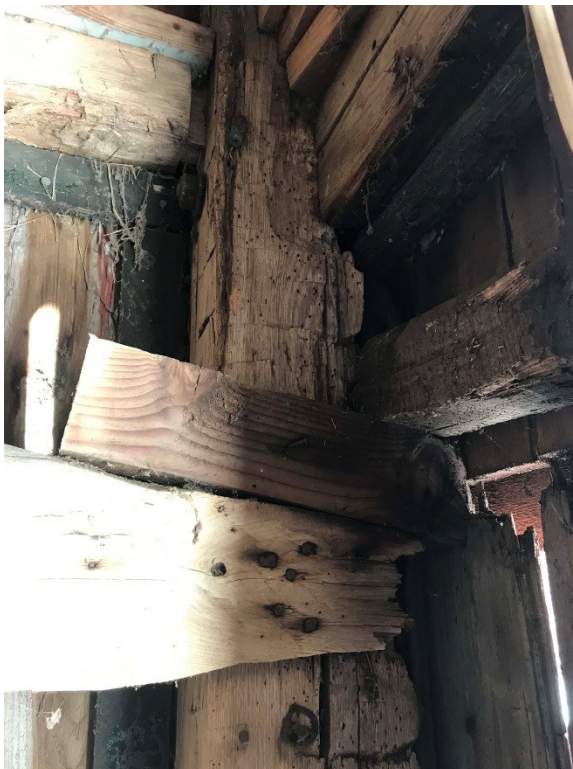
**Photo I-12.** View showing wood rot and loss at the northeast corner post in Room G001.

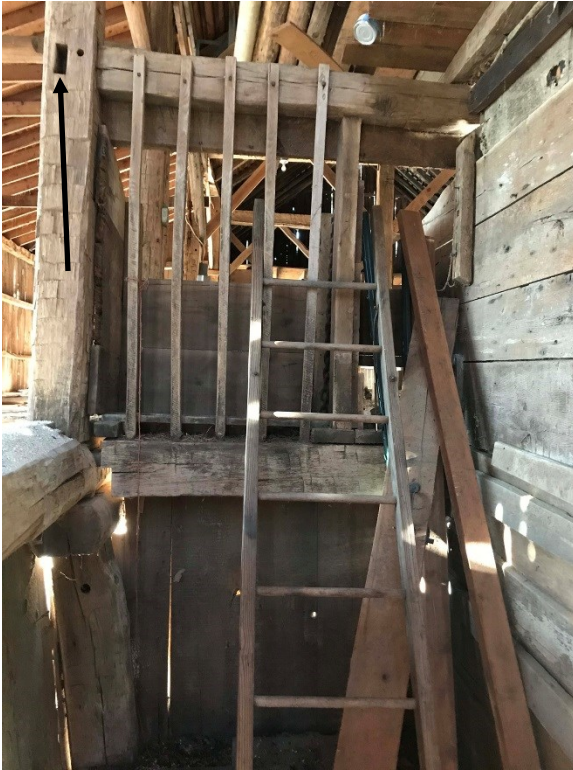
**Photo I-13.** View looking west in Room G003 showing loss of a horizontal beam at the enclosure.

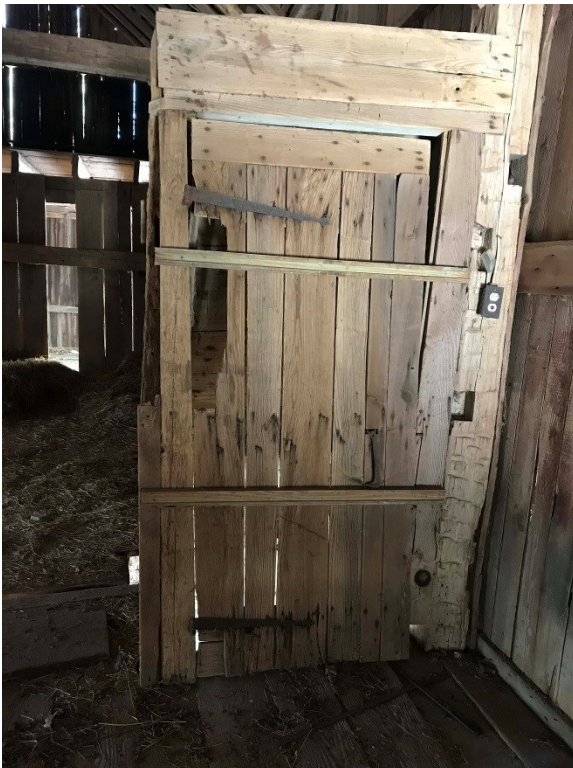
**Photo I-14.** View of door D110 showing wholesale loss at one board, gaps between boards, and displacement within the opening.

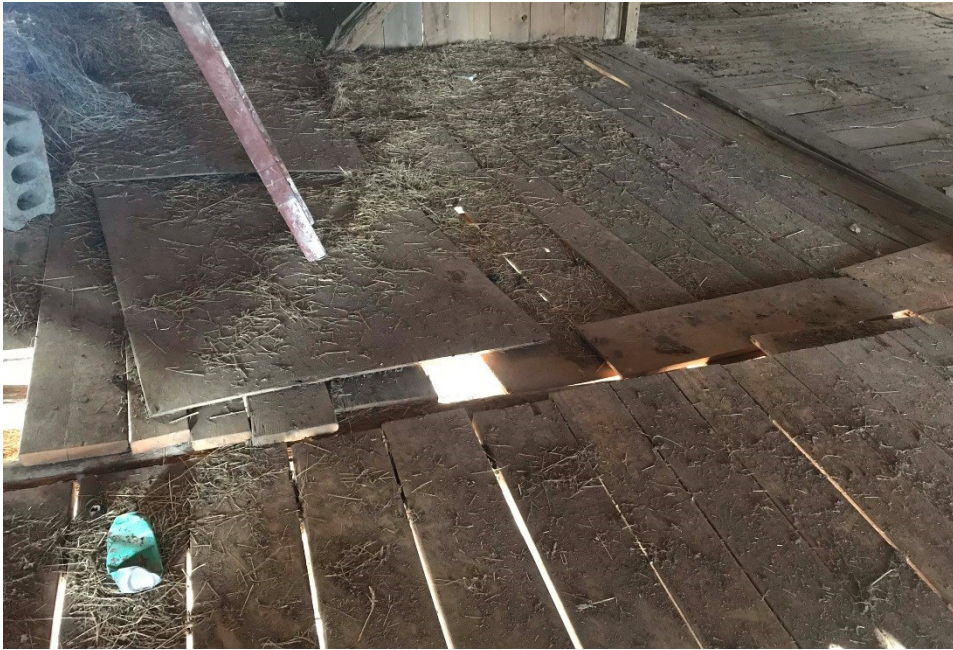
**Photo I-15.** View showing loss and unevenness at the floor.

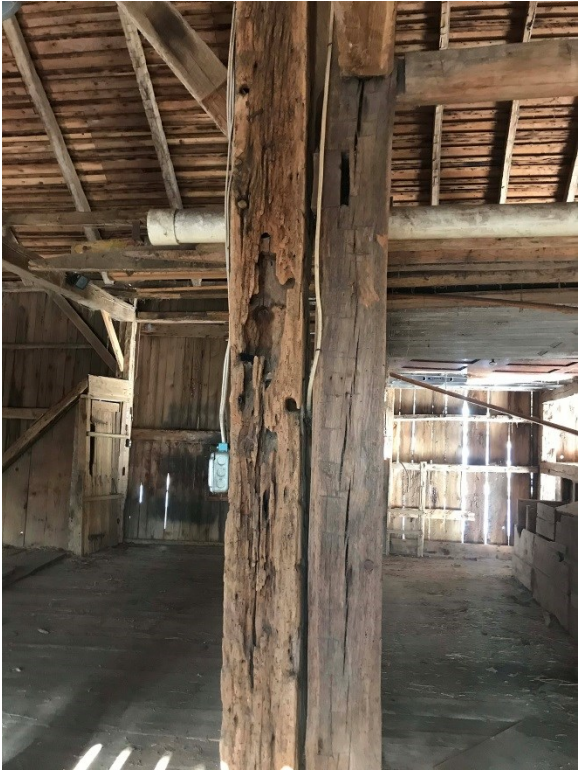
**Photo I-17.** View showing significant water damage at a post in Room 101.

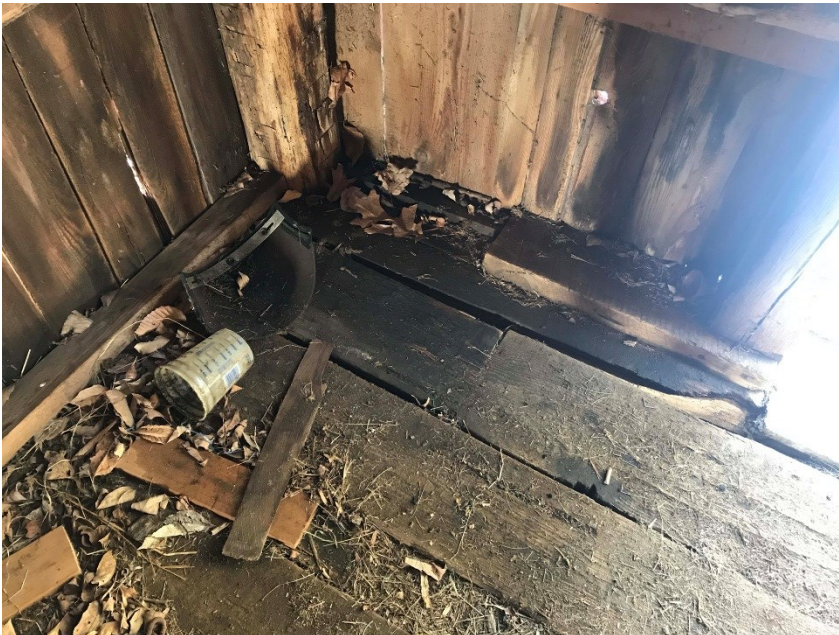
**Photo I-18.** View showing wood rot and moisture damage at the northwest corner of Room 102.

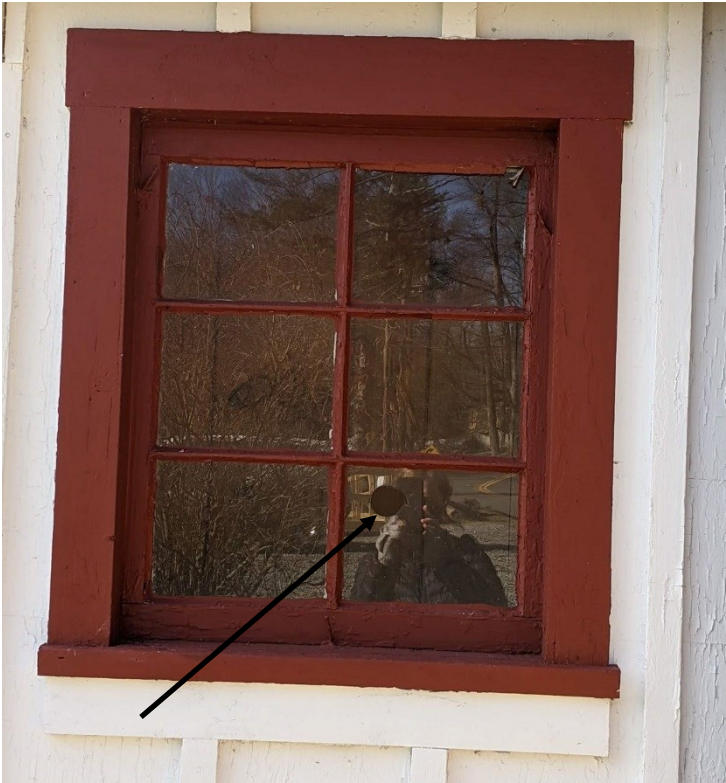
**Photo E-5.** View of window W102 showing a hole in the bottom right pane.

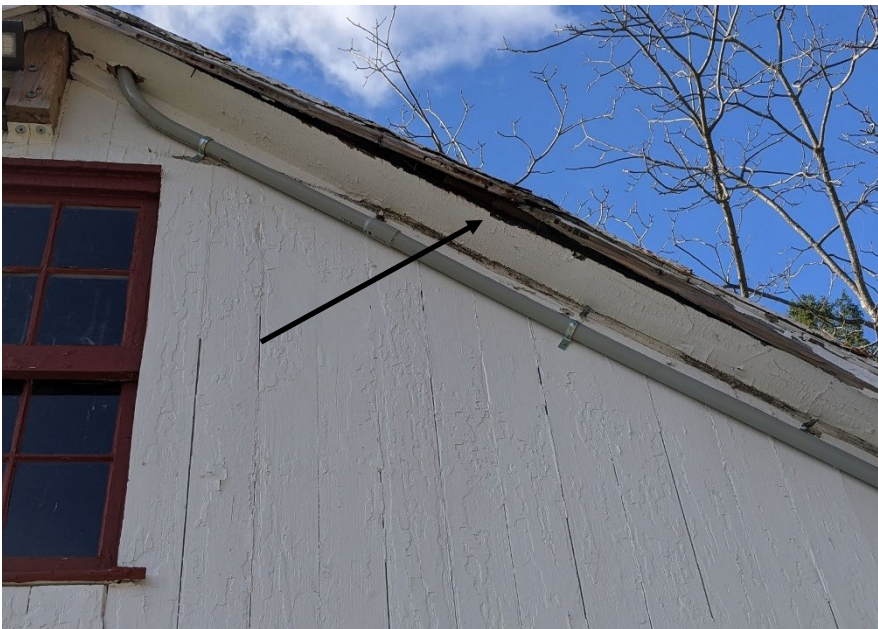
**Photo E-6.** View showing wood rot and loss at the rake board and soffit at the east elevation.

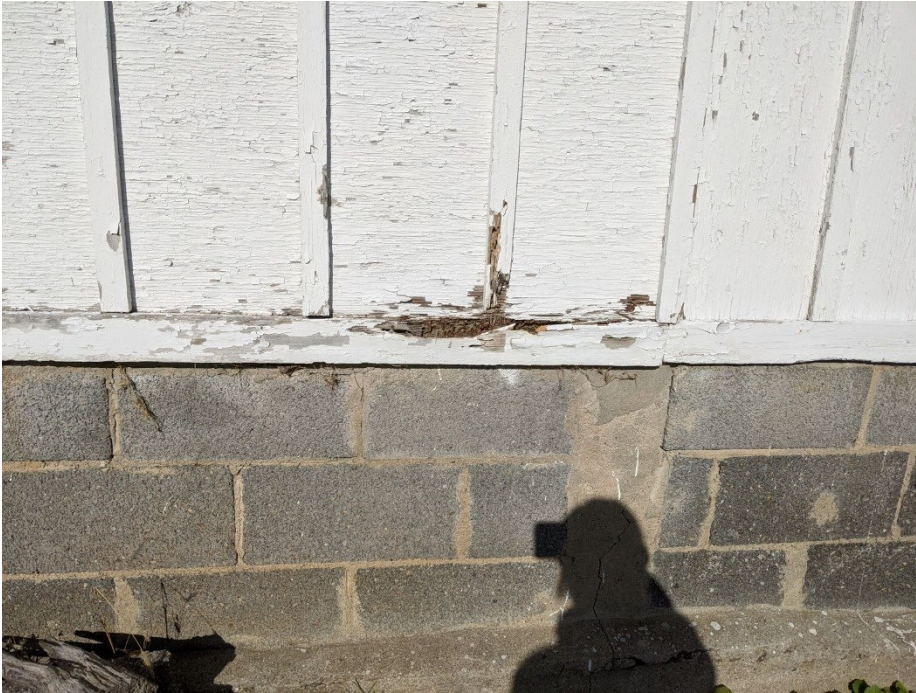
**Photo E-7.** View showing loss at the skirt board at the south elevation. Also note the vertical seam in the foundation below.

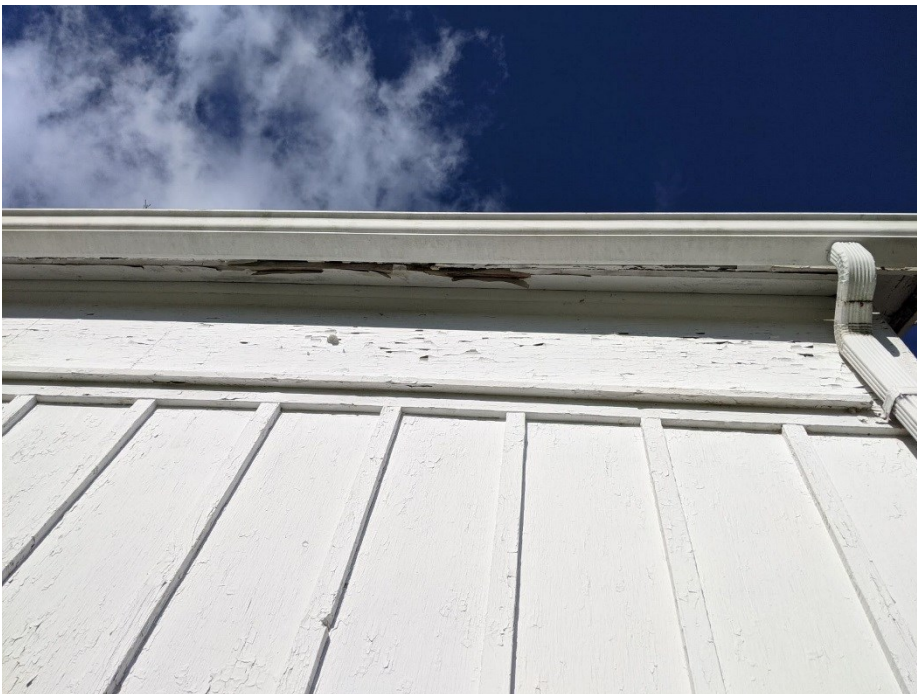
**Photo E-8.** View of the soffit showing wood rot.

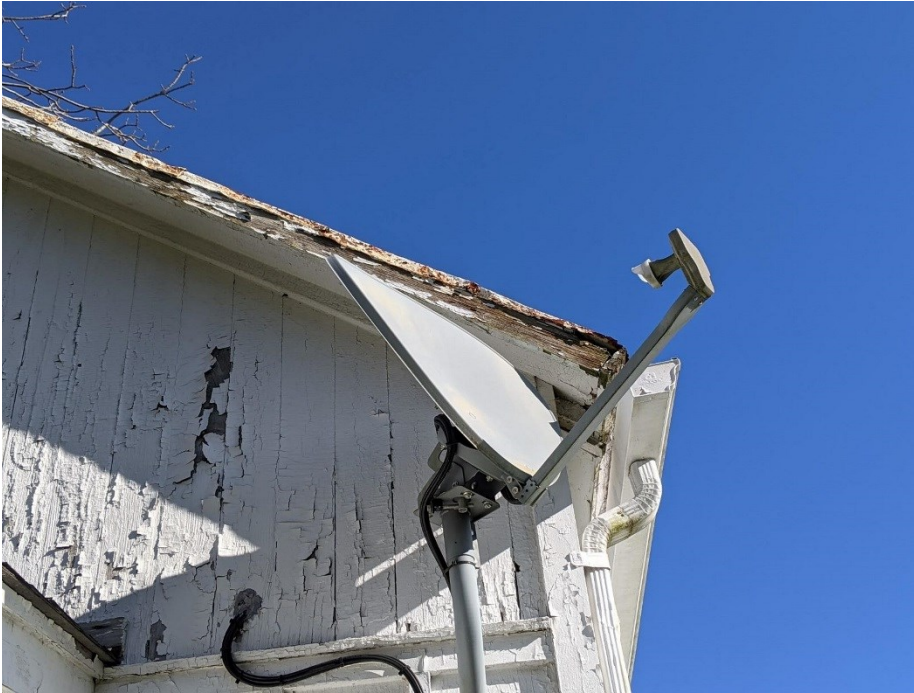
**Photo E-9.** View showing wood rot and loss at the rake board at the west elevation. Also note the paint failure at the siding.

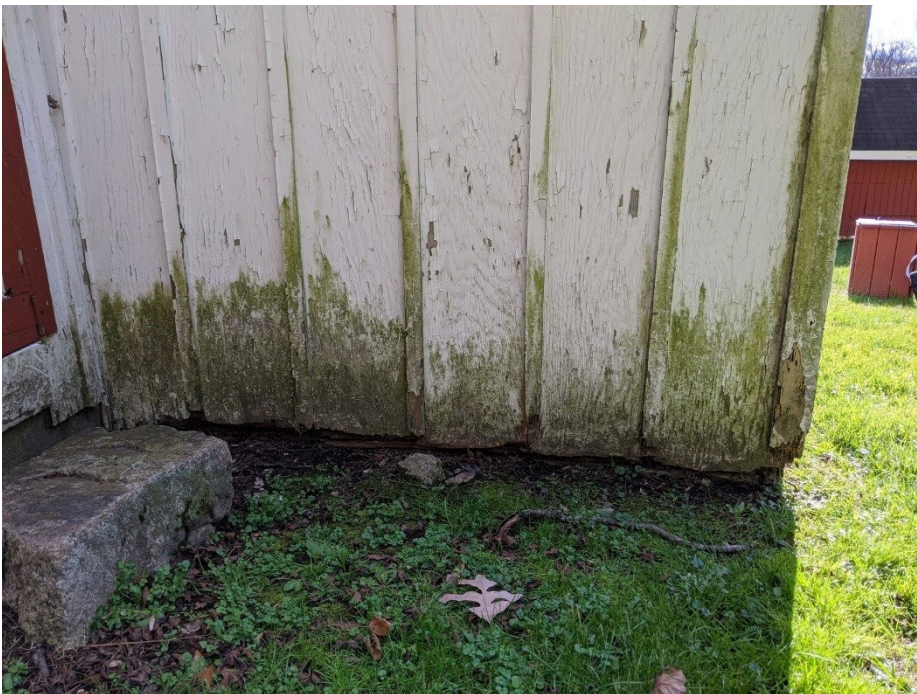
**Photo E-10.** View looking south at the shed extension showing significant biological growth and loss at the base of the siding.

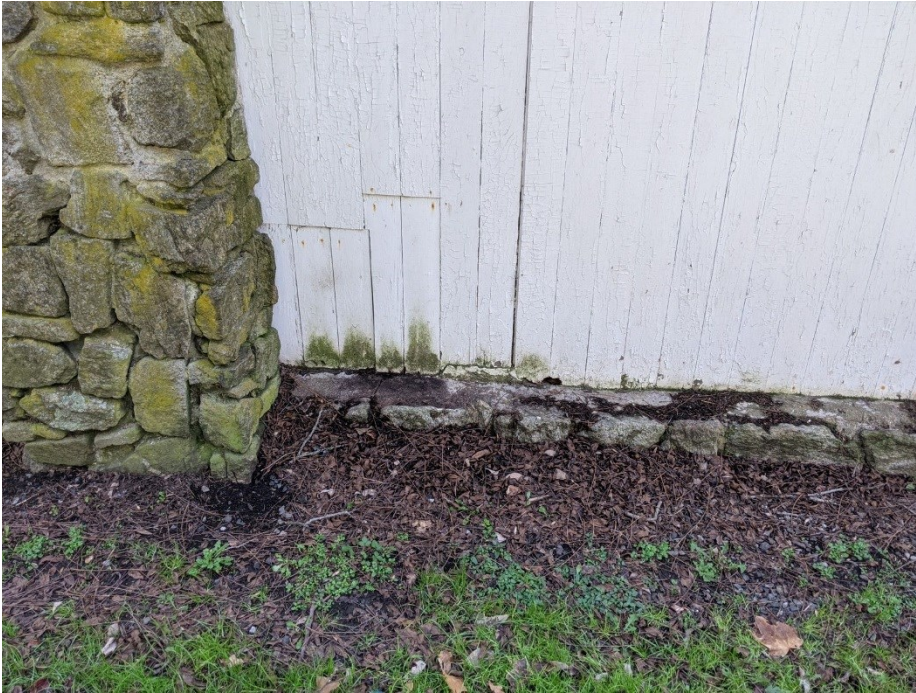
**Photo E-11.** View showing biological growth and loss at the base of the wood siding adjacent to the chimney. Also note the mortar loss and biological growth at the chimney.

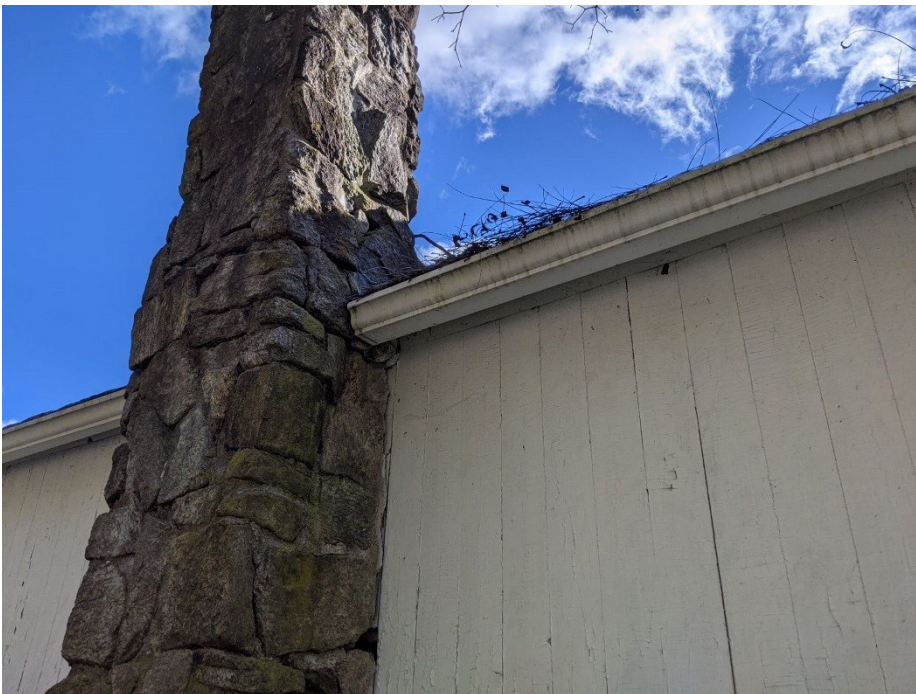
**Photo E-12.** View showing debris at the gutter adjacent to the chimney.

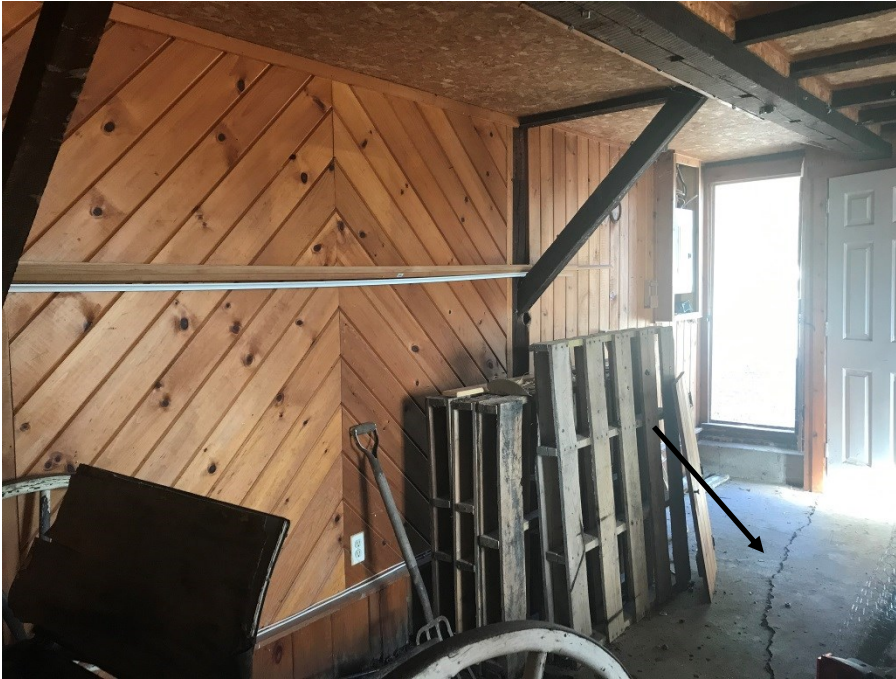
**Photo I-5.** View showing a significant crack in the concrete floor.

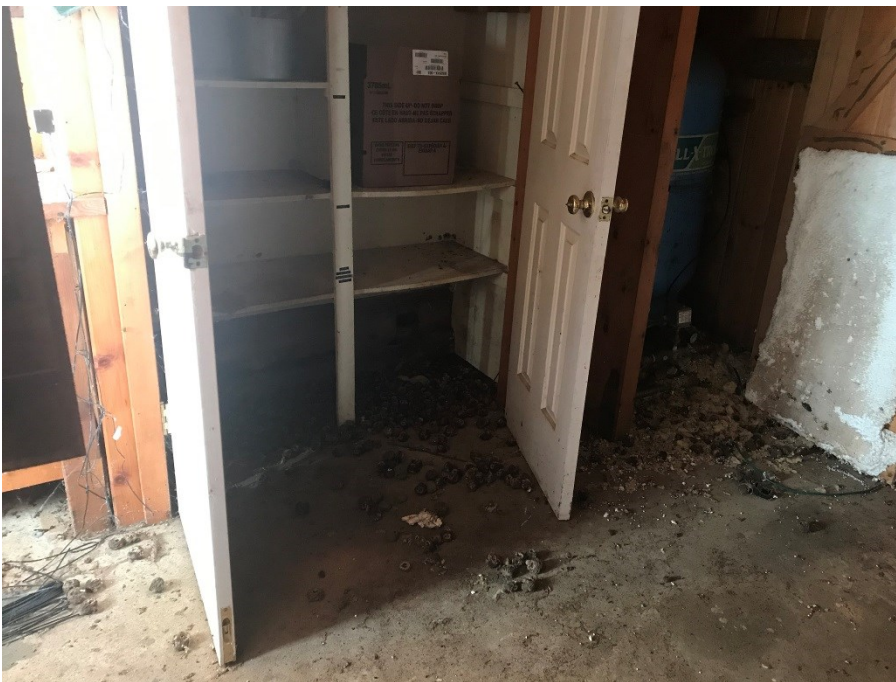
**Photo I-6.** View of the closet in the southwest corner, which are heavily soiled from animal activity.
