V. COMMUNITY FACILITIES PLAN

INTRODUCTION

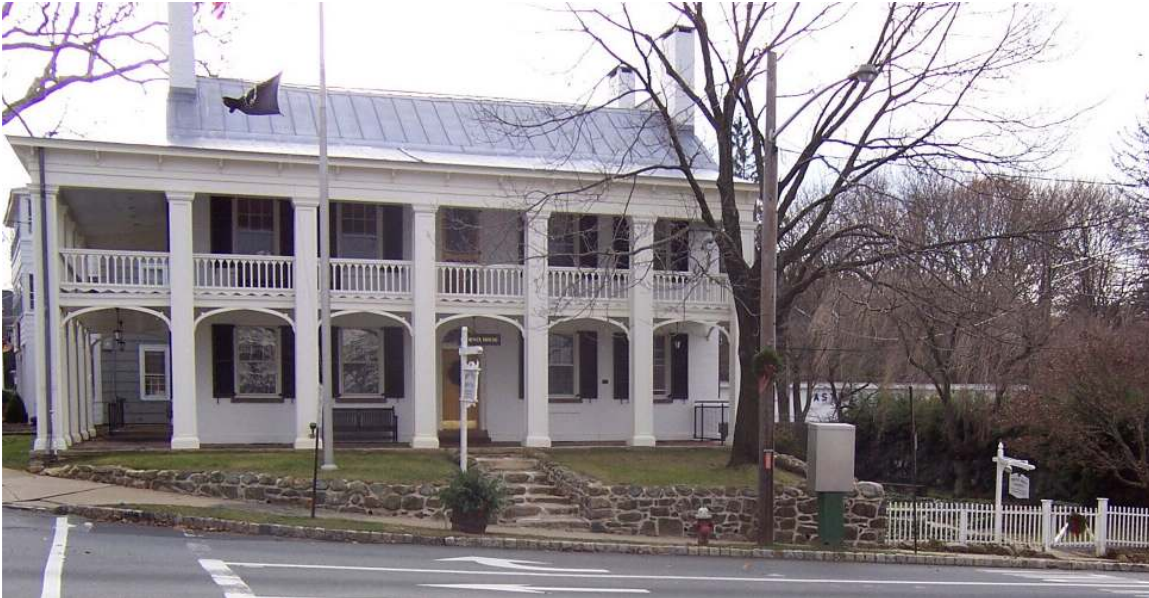
The Phoenix House is generally in very good shape, primarily due to the exterior and structural work completed in 2004. The interior of the building will need attention in the next five (5) years; primarily the windows, carpeting, painting, and wallpaper will need to be updated. The Public Works Department, with landscaping assistance by the Mendham Garden Club, maintains the grounds around the building in good order.

With the addition of a first floor ramp to a renovated exterior door, The Phoenix House currently is handicap accessible. Wheelchair bound visitors are able to access the parlor via this arrangement and can meet with officials in the parlor. If privacy is needed, the parlor can be segregated from the rest of the building.

The recent renovation of the Phoenix House caused some damage to this 5200 square foot garden. The Garden Club is working to replace selected specimen plants, recondition the soil, and patch areas where heavy foot traffic and equipment damaged the garden. The Mendham Garden Club has been funding this work. Additional needs include irrigation, grading improvements, additional plantings, and new fencing.

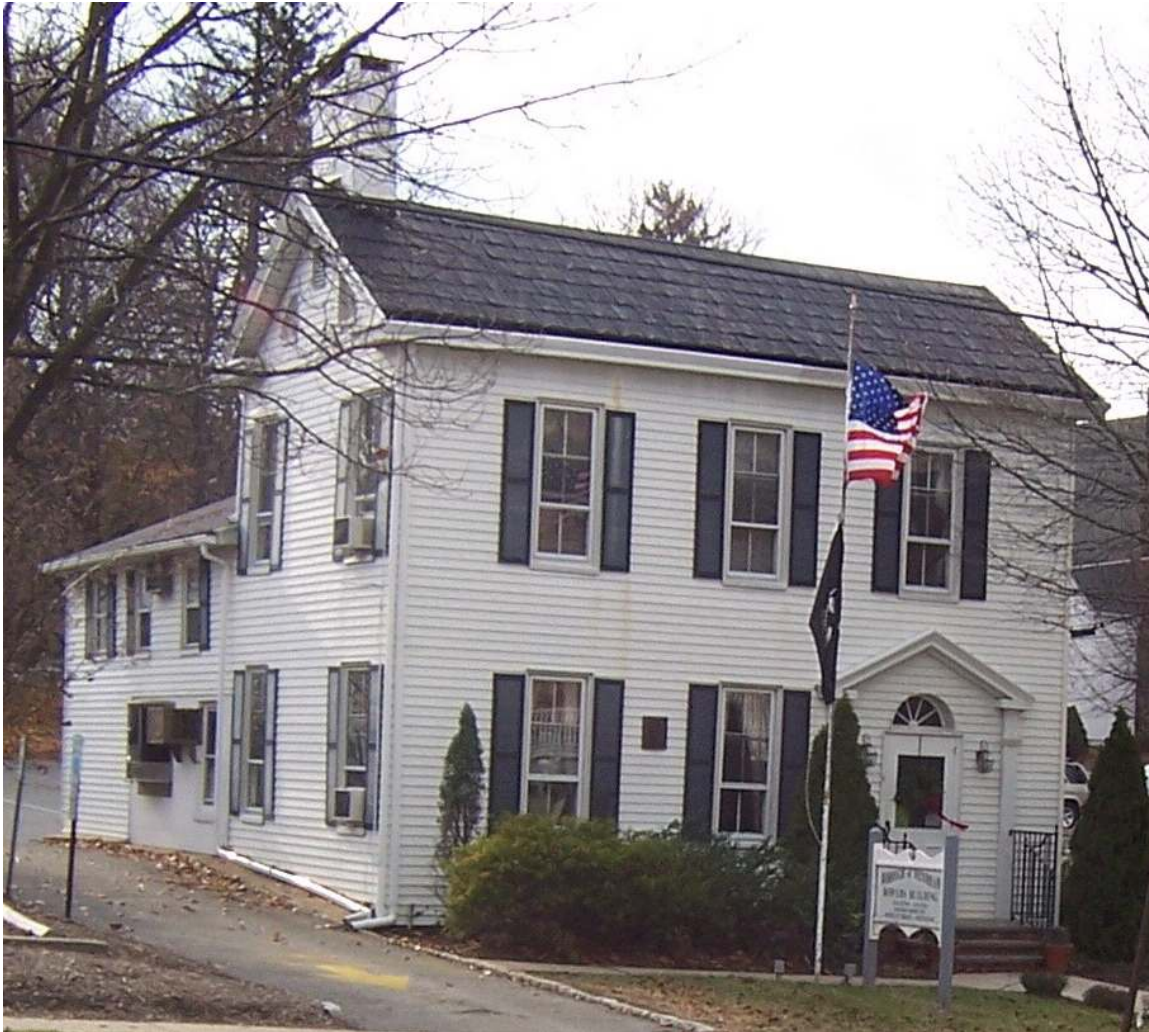
The Bowers Building is in moderately good condition. Some exterior maintenance work needs to be addressed and the turning radius around the building as drivers approach the drive-up window should be reviewed along with the parking configuration.

The Bowers Building is not handicap accessible. The second floor has multiple levels, which require the public and staff to navigate several levels of steps.

The interior of the building needs to be addressed, including painting, wallpaper, and new carpet. The first floor, stairs, and Construction Code office on the second floor get significant use by the public.

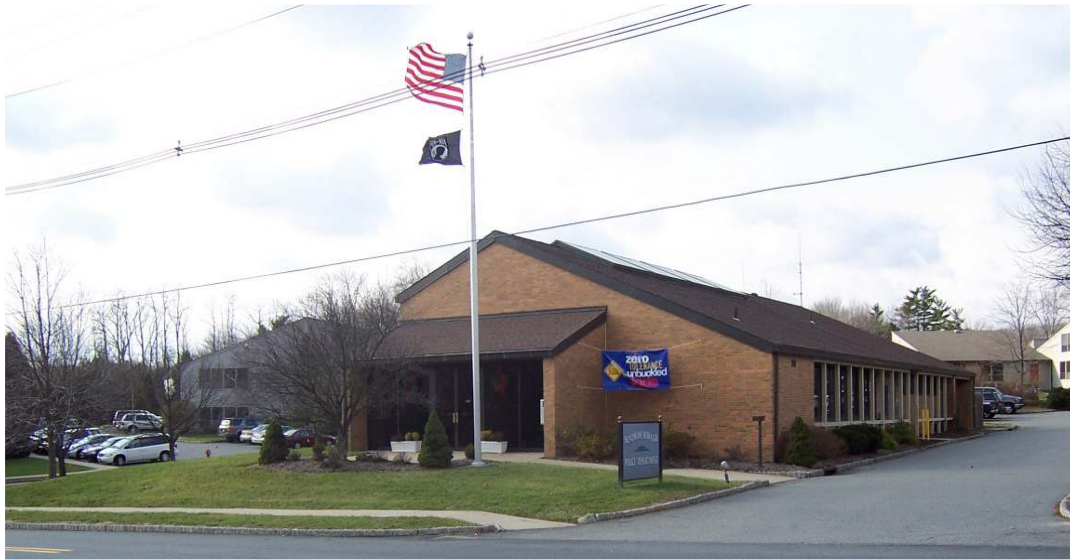
Police Headquarters is located at 3 Cold Hill Road South on 0.75 acres of land. The building was completed in 1984 and contains 5804 square feet. The one-story building includes five (5) offices, one conference room, and two (2) locker rooms: 1-male, 1-female. The building includes a sallyport- private entrance and exit for prisoners, a security area that includes two (2) cells, one processing room, and an alcohol testing room. Other rooms include: an armory, evidence room, command area, dark room, utility closet, and two (2) public restrooms. The building is handicap accessible.

The size and location of the building are appropriate for its current and future use. The overall condition of the building is good. There would be no anticipated alternate use for the building. Site amenities are all good.

Future needs for the building include an interview room. Morris County will supply all the recording equipment, but the room must be a dedicated room. Additional parking will also be necessary, and a storage shed will be required for the storage of patrol bikes and other equipment.

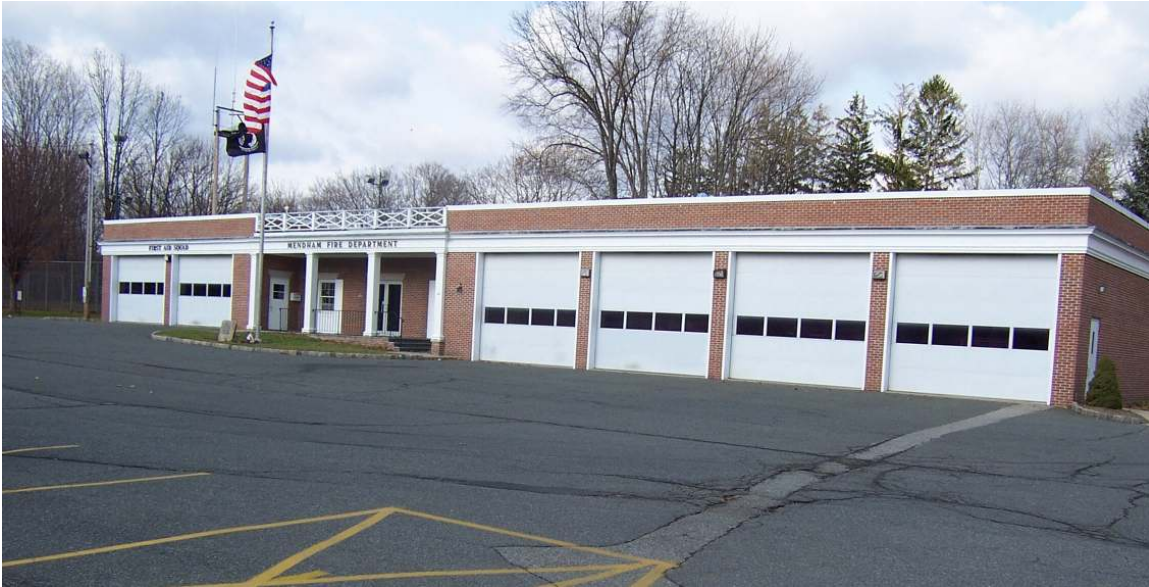
Fire & First Aid Building

The building is located in the center of the Borough on the main east – west roadway. It is, therefore, an ideal location for the Fire Department and First Aid Squad to respond to calls in the Borough. It also provides easy access to volunteer members responding to the firehouse from all parts of the Borough. There does not appear to be any preferred alternate use for this building due to its location and size. The building is handicap accessible with wheelchair access through the main entrance and with handicapped facilities in the restrooms.

The building interior and exterior structure are in good condition and are well maintained. A new emergency generator was installed in 2005 to provide electrical service to the entire building in the event of a power failure in the Borough.

A possible solution to the size problem of the existing building would be to re-locate the First Aid Squad to a building of its own that is centrally located in the Borough. If an existing building centrally located in the Borough were to be found, it would need to be renovated to accommodate the First Aid Squad and its ambulances and equipment.

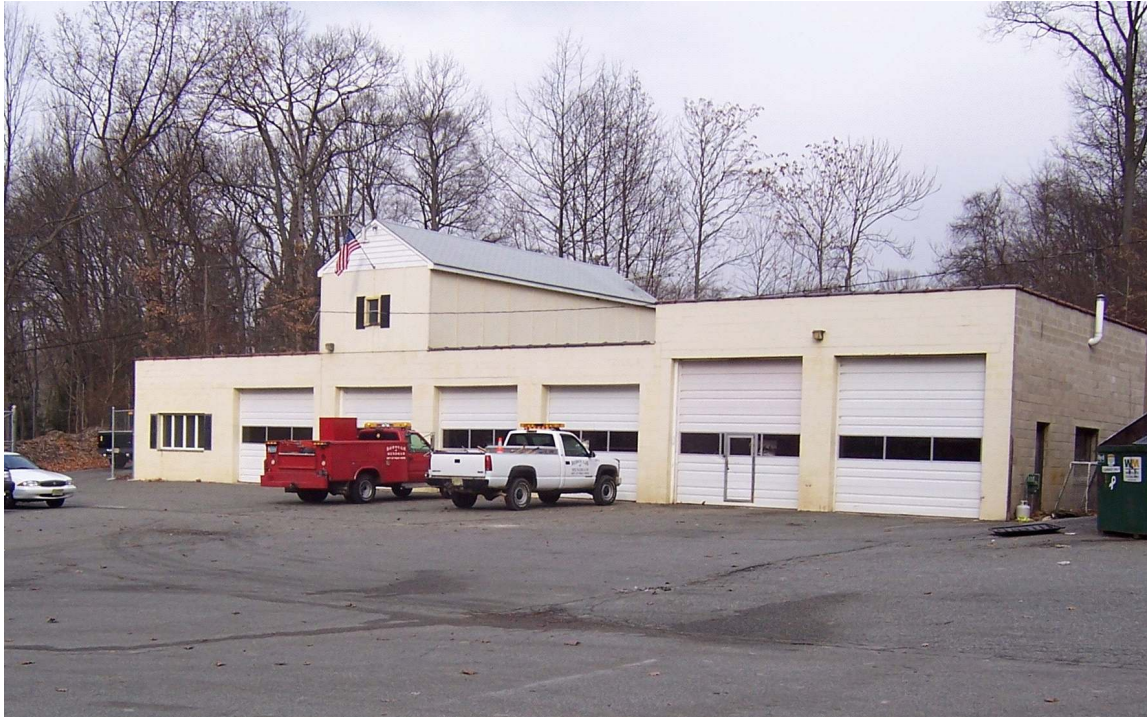
DPW Main Garage

The building is too small for its current uses and the layout is poor. Specifically, additional room is needed for employee amenities, such as an appropriate locker room, break room, and bathroom facilities. A dedicated area for repairs of medium to small equipment is also needed. A small meeting room and expanded office space would also improve the efficiency and effectiveness of the Department.

Structurally the building is in good to fair condition. During heavy rain, water leaks through the back wall of the building which is built into a slope. The electrical system is outdated and over loaded and should be completely upgraded. The building currently lacks a fire alarm system. Storage space in the building is limited, which causes overcrowding in the vehicle bays.

To address the storage and space issues, the possibility of adding a second floor to the building has been considered. Preliminary plans have been developed, and the second floor could also house an ancillary meeting room for small, Borough government meetings as well as document storage.

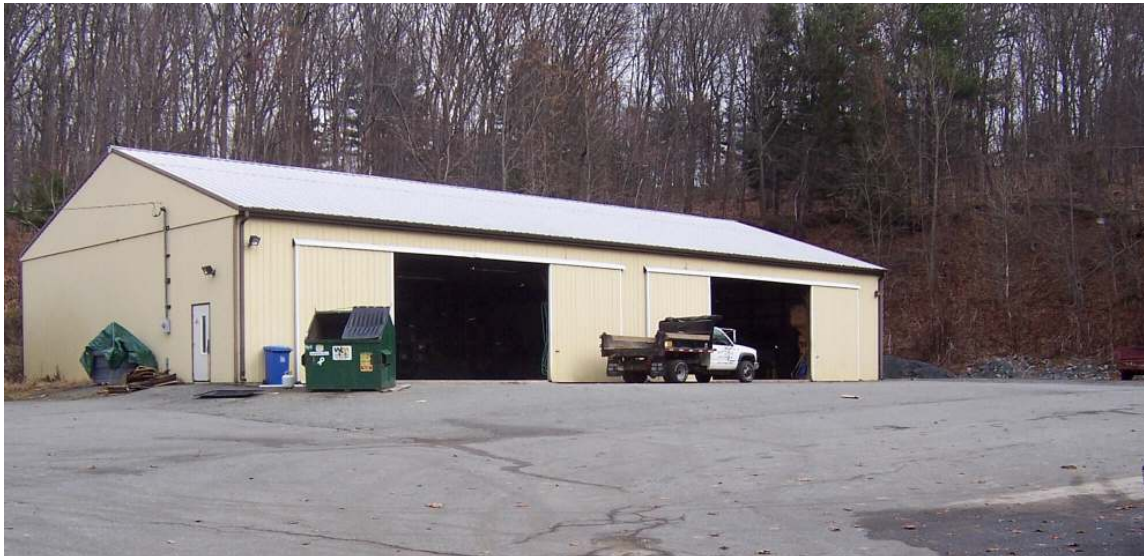
DPW Storage Barn

Condition is good.

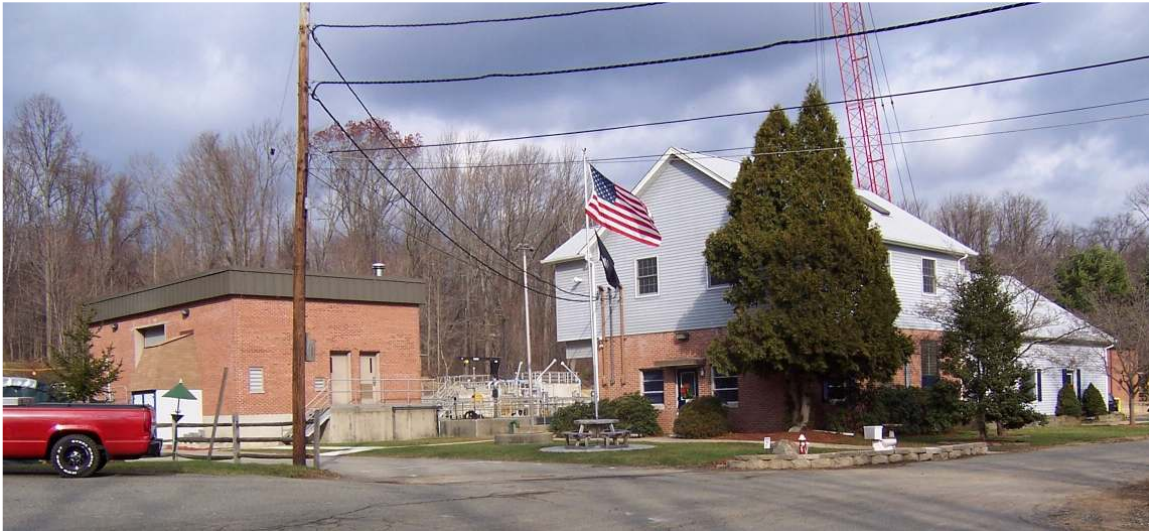
Sewer Plant

The condition of most structures at the facility is very good. One control shed needs to be replaced. Most of the facility is not handicap accessible, but residents are not expected on-site.

Exterior lighting at the facility has recently been improved. However, the entrance driveway needs to be rebuilt with proper drainage. A storage barn will be built to satisfy current and additional equipment needs. The landscaping is good except in the construction area.

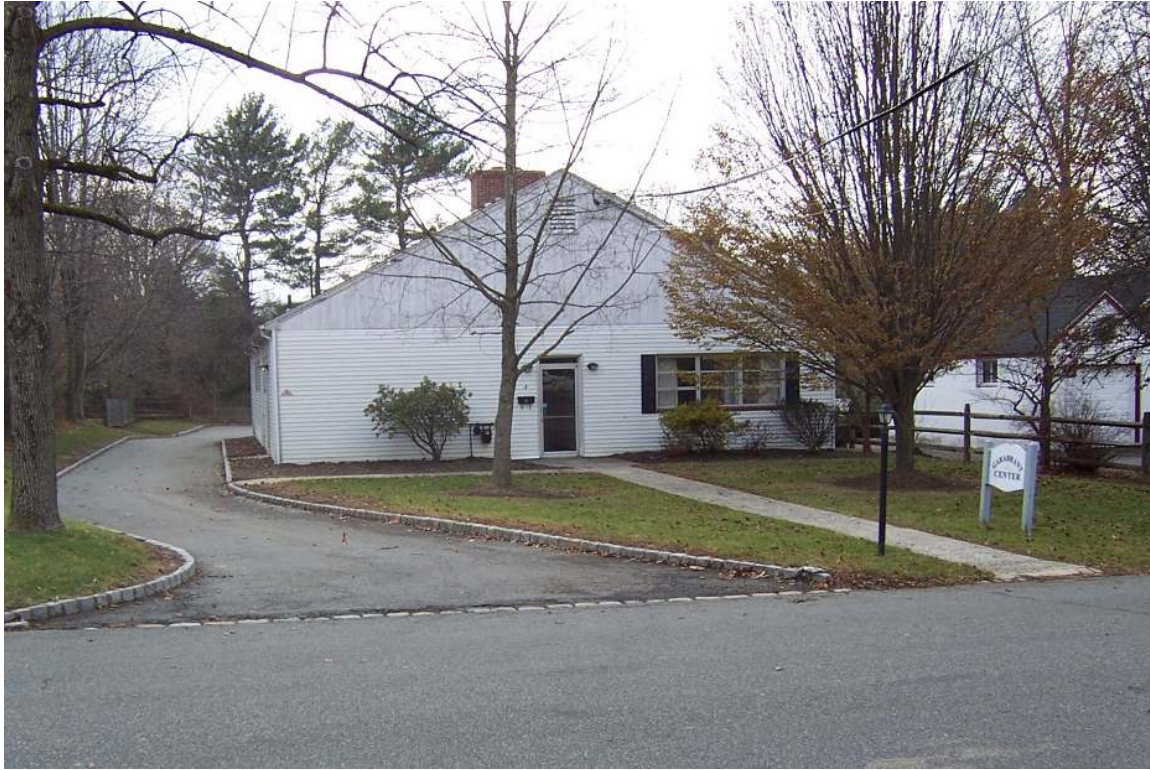
The building is structurally in good shape. However, the windows and the roof will need to be replaced in the near future. The air conditioning and heating system need to be replaced now. The building is handicap accessible.

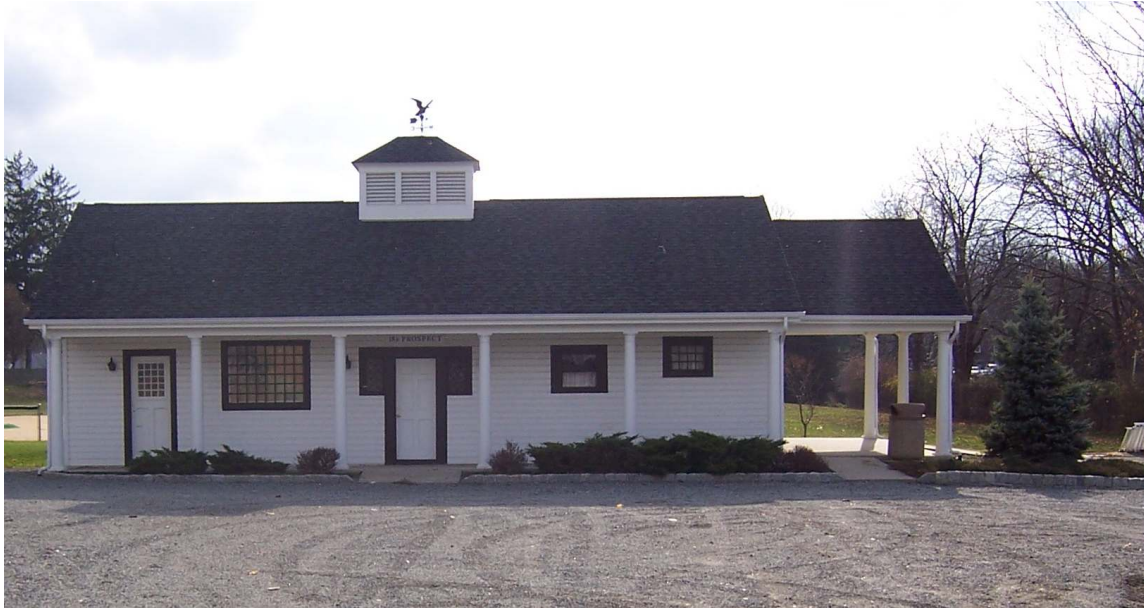
The light and landscaping are appropriate for the building use and location. Due to reoccurring vandalism to the restrooms, a surveillance/security system is being contemplated.

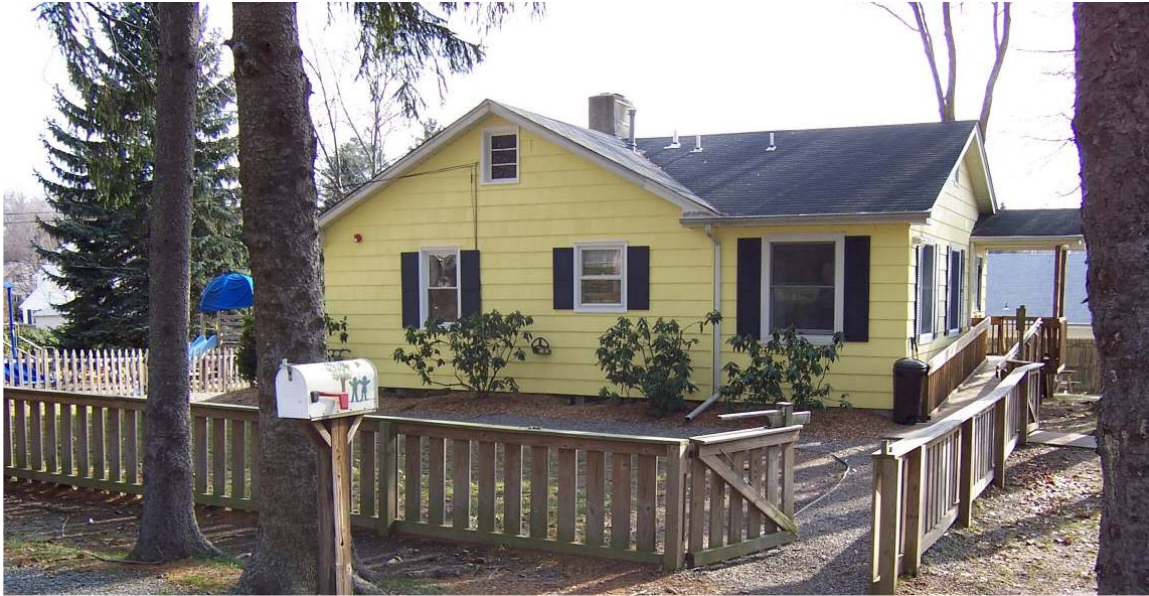
The Mendham CO-OP Nursery is responsible for the interior (decorating) maintenance of this building per the lease agreement. The building is in good condition. The Borough is responsible for the exterior maintenance of the building, heating, plumbing, and grounds. Some potential future improvements are replacement of windows and paving of walkways on the property. The main floor is handicap accessible, but the classroom in the basement is not.
